## T-34 DISCONNECTION IN 1ST ECMV FILL SWITCH SYSTEM

T-35 DISCONNECTION IN 2ND ECMV FILL SWITCH SYSTEM

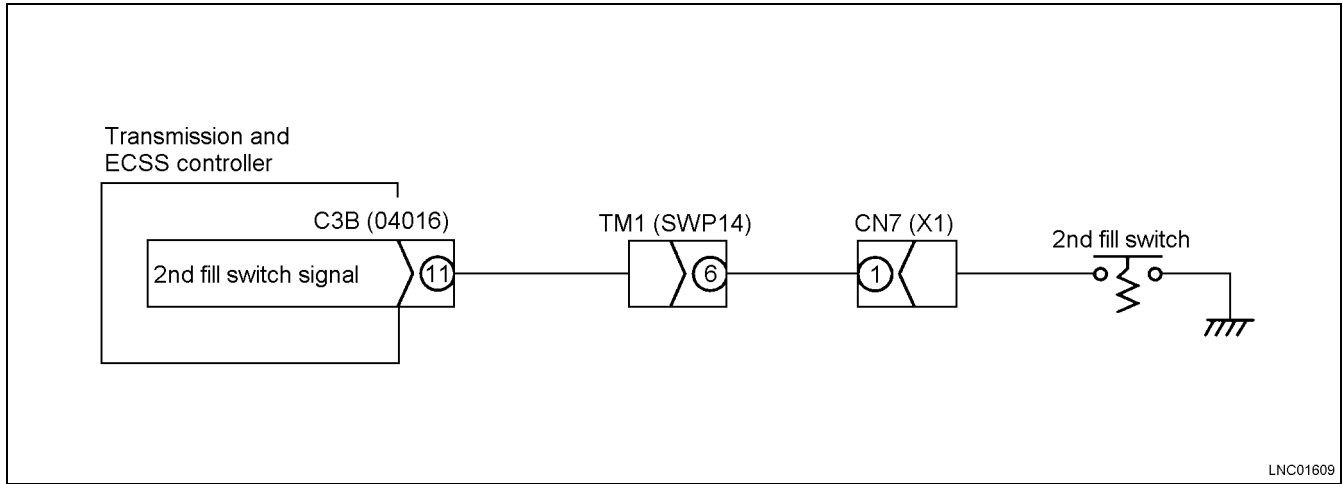
T-35 Related electrical circuit diagram

Is voltage between CN7 (1) and chassis normal?

Is resistance between C3B (female) (11) and chassis normal when CN7 (female) (1) is grounded to chassis?

Cause	Remedy
Defective transmission controller	Replace
Defective contact or disconnection in wiring harness between C3B (female) (11) - TM1 (6) - CN7 (female) (1)	Repair or replace
Defective 2nd ECMV fill switch	Replace
