MODEL All  
with rain/light sensor

P67.10-2407-03

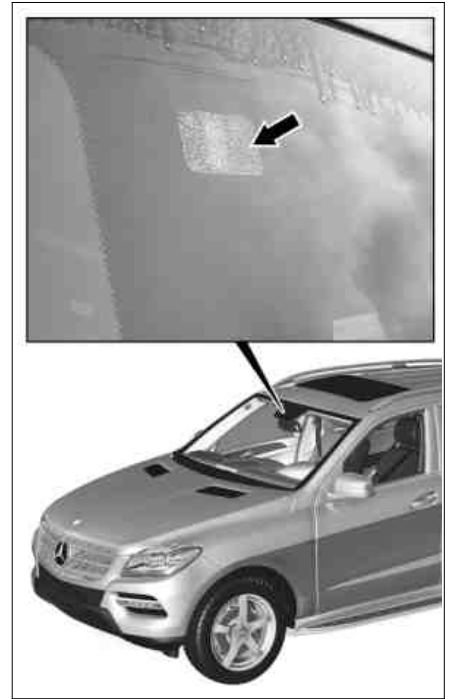
Shown on model 166

**i** For the complaint "*Random wiping of windshield wiper*" because of faulty bonding of the window positions in the area of the rain/light sensor (see picture), the damage code 67001 19 (cosmetic fault) is to be used when replacing the windshield.

Remove, install windshield		AR67.10-P-1000RT
--	----------------------------	--	------------------
