TRACK MAINTENANCE (CONT'D)

Track Damage Identification (Cont'd)

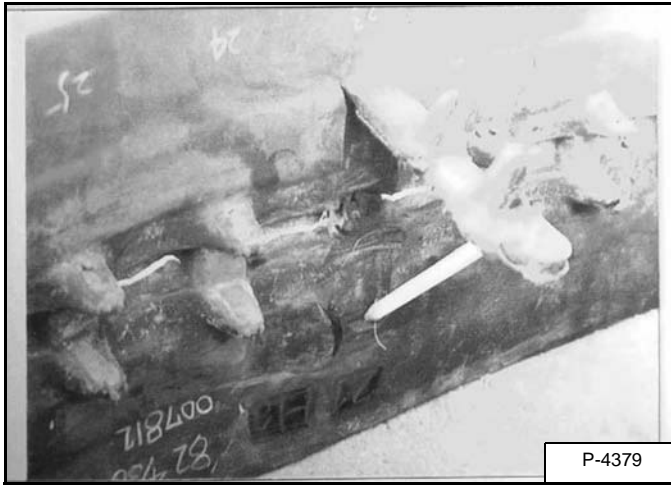
Figure 40-30-7

Separation Of Embedded Metals

Extraordinary outer forces applied to embedded metals cause their separation from the rubber track's body [Figure 40-30-7].

Even a partial separation of embedded metals requires replacement of the track.

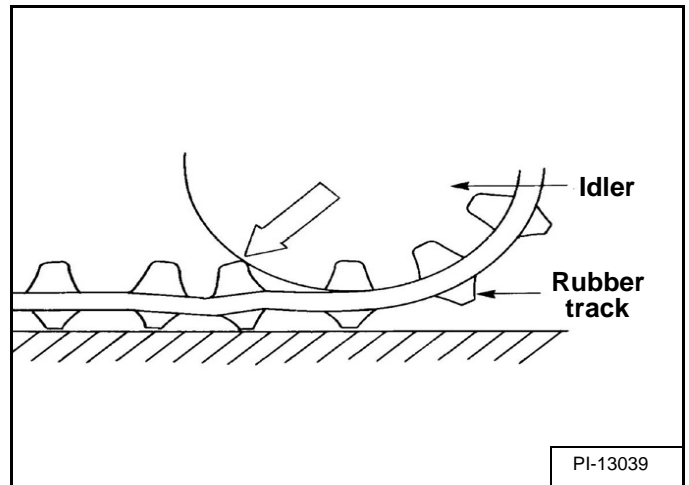
Figure 40-30-8

Embedded metals are adhered between the steel cords and the rubber body. The following cases generate external forces greater than the adhesion strength, causing separation of the embedded metals:

When the idler continually rides on the projections of embedded metals, the embedded metals will eventually peel off [Figure 40-30-8].

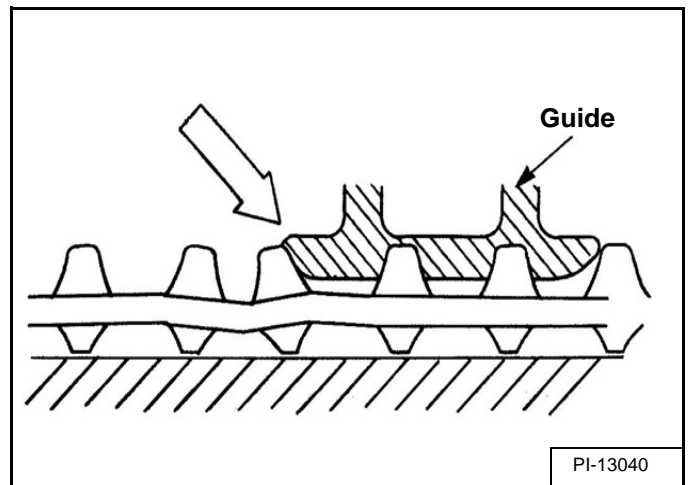
Figure 40-30-9

When a rubber track is detracked, it becomes stuck between the guide or the undercarriage frame, causing the separation of embedded metals [Figure 40-30-9].

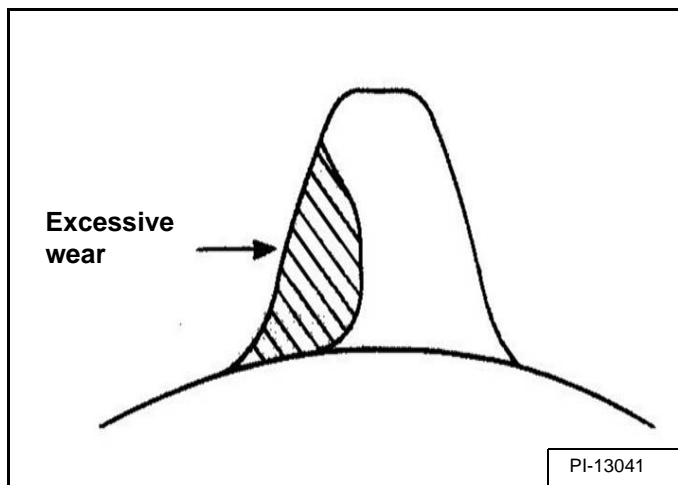
Figure 40-30-10

Excessively worn sprockets, example shown **[Figure 40-30-10]** will pull embedded metals out of the track.

Recommended track tension should be periodically checked. (See DRIVE SYSTEM TOC on Page 40-01.)

Quick turns on bumpy and rocky fields should be avoided.

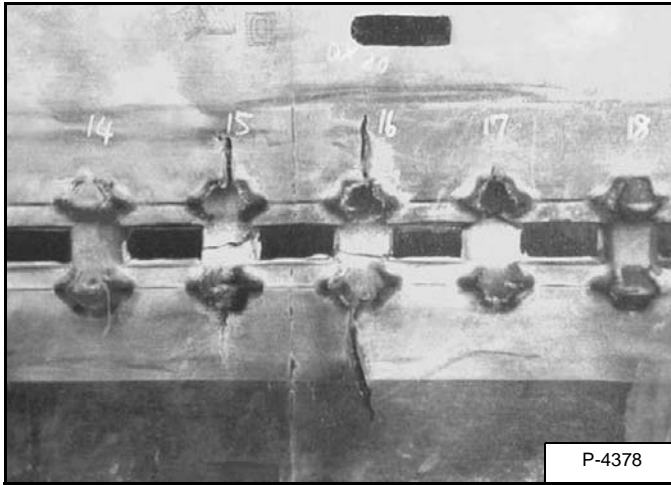
Figure 40-30-12

Separation Of Embedded Metals Due To Corrosion

Due to corrosion of embedded metals, the adhesion to the rubber body deteriorates, resulting in complete separation [Figure 40-30-12].

Even a partial separation of embedded metals requires a rubber track replacement.

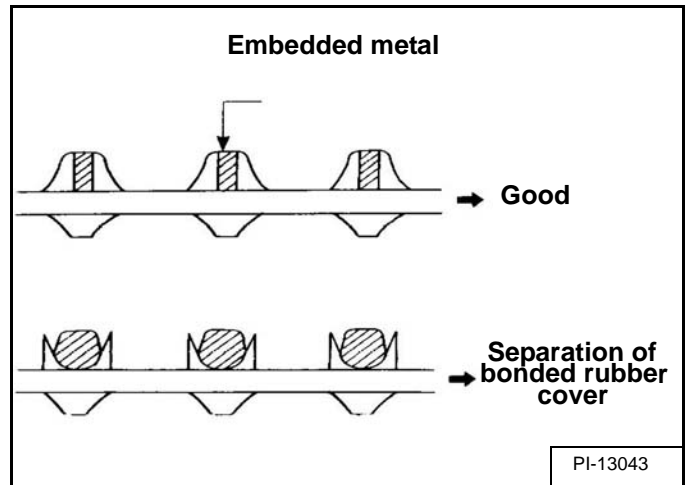
Figure 40-30-13

Embedded metals are bonded to the rubber body. The following operating conditions cause embedded metals to corrode, causing deterioration of the bonding, and finally resulting in separation of the embedded metals from the rubber body [Figure 40-30-13].

Excessively salty fields, like the sea shore

Strong acidic or alkali soil conditions

Compost spread grounds

On tracks that are out of adjustment, the track rollers, idlers and sprockets will gradually wear the rubber surface at track roller side, causing exposure of the embedded metals. Consequently the embedded metals will corrode resulting in their separation from the rubber body.

If rubber tracks are used under such field conditions as described under (Causes of the damage), they should be washed with plenty of water. After being completely dried, they should be stored correctly.

When the bonded rubber cover is separated from the embedded metal projections and the metals in the rubber body become loose, it is time to consider replacement of the rubber track.

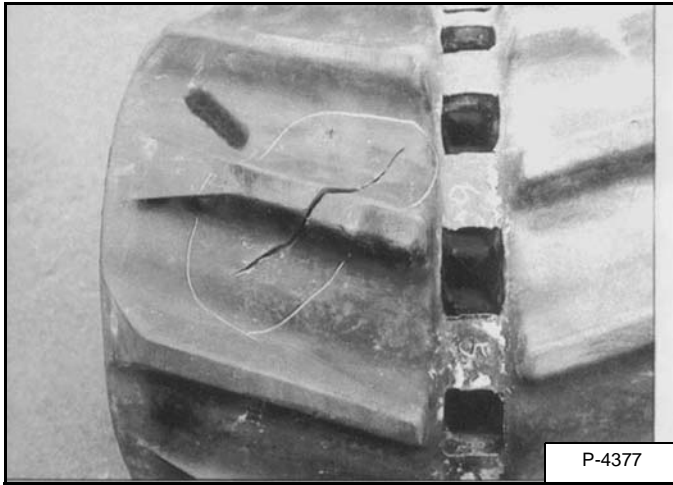
Figure 40-30-14

Cuts On The Lug Side Rubber

Cuts on the lug side rubber often occurs as one of the most typical failure modes [Figure 40-30-14].

When a cut on the lug side rubber reaches the embedded steel cords, it should be immediately repaired with cold vulcanization rubber.

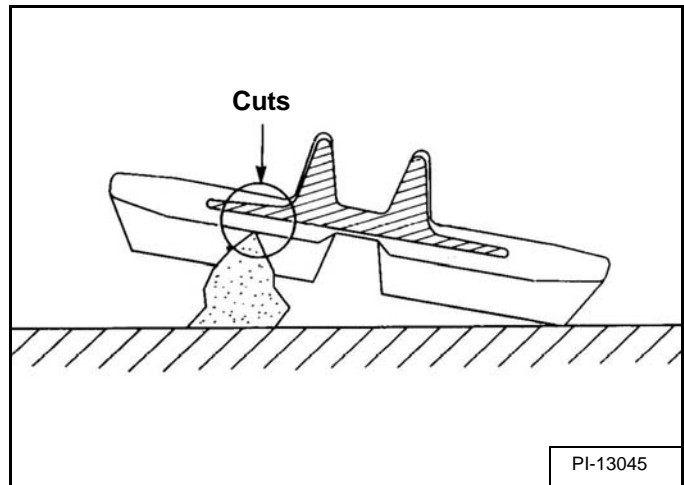
Figure 40-30-15

When rubber tracks drive over projections or sharp stones in the fields, the concentrated forces applied cause cuts on the lug side rubber surface. In case of making turns on projections, the lug side rubber surface will have an even higher chance to be cut. If the cuts run through the embedded steel cords, it might result in the steel cords' breakage due to their corrosion. It is highly recommended to repair the cuts with cold vulcanization rubber as soon as they are observed [Figure 40-30-15].

Machine operators are requested to drive with great attention to the ground's surface especially in terrains of the following type:

- Construction sites
- Demolition sites
- Paths covered with rocks and wood
- Concrete ridges
- Stumpy fields

When operating on terrains as mentioned above, high speed, quick turns and overloading should be avoided.

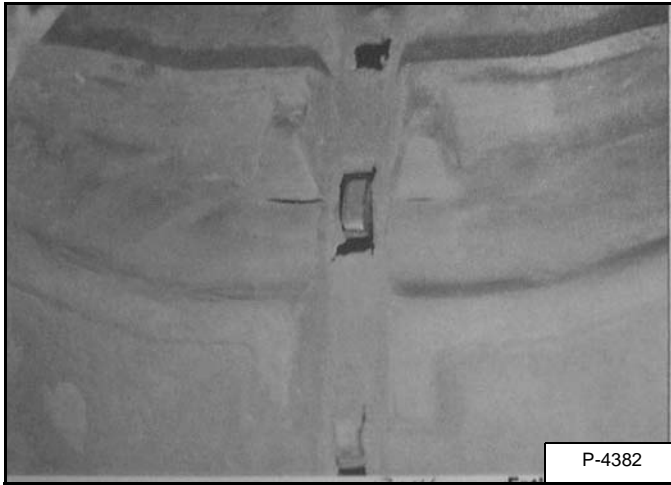
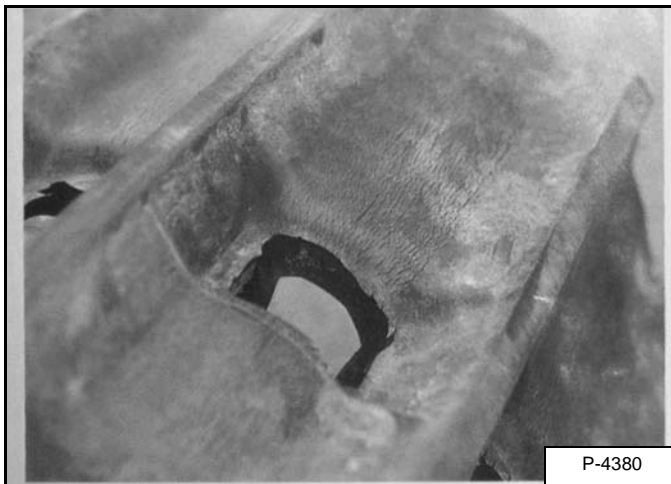
Cracks On The Lug Side Rubber Due To Fatigue

Small cracks around the root of the lug as a result from operation fatigue [Figure 40-30-16] and [Figure 40-30-17].

Because of wound stress applied to rubber tracks around the undercarriage parts during operation, the fatigue especially causes cracks on the lug side rubber surface. Once the cracks occur, they gradually deteriorate with even small external cracks. Also when operating near seashores or under cold temperatures, rubber tracks are more likely to suffer from ozone cracks.

When the cracks reach so deep that they expose the steel cords, track replacement is required.

Rubber tracks are designed with special rubber compounds to prevent cracks due to fatigue. However, external injuries on the lug side rubber sometimes cause more chance of cracking. Machine operators should observe soil conditions when driving, so as not to cause external injuries to the lug side rubber. In order to minimize the occurrence of ozone cracks, attention should be paid to the following instructions for maintenance:
