13-3430 Examining poly V-belt, damage patterns

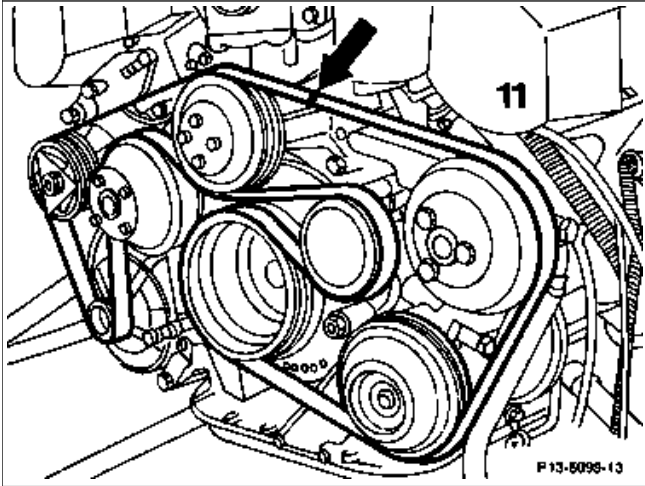
- Poly V-belt (11)..... mark with chalk at a clearly visible point (arrow).
- Engine..... crank with starter in stages (01-0110).
- Poly V-belt (11)..... examine for signs of damage.
- Examination..... ended once marking (arrow) is again visible (one full revolution of belt).

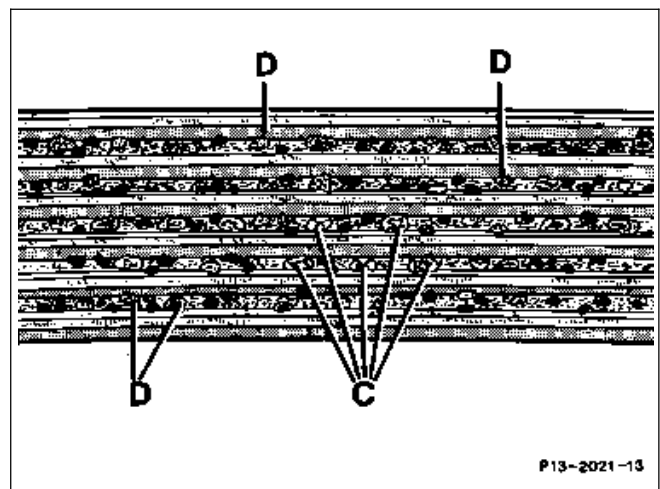
- Rubber clumps in base of belt (C), dirt or grid embedded (D).

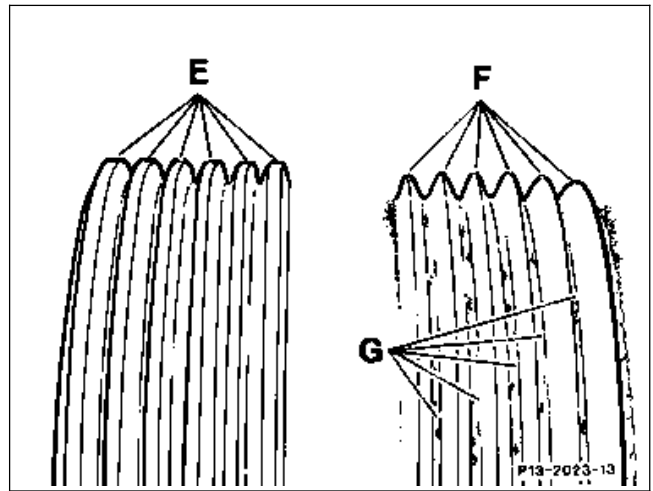
- Wear to flanks (F)
Ribs are pointed - trapezoidal in shape when new (E) and cord is visible in base of belt (G, lighter points).

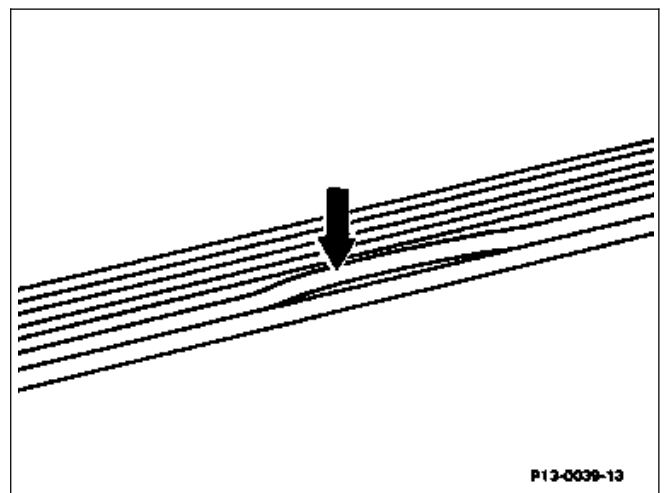
- Rib (arrow) detached from base of belt. Splitting across several ribs (H).

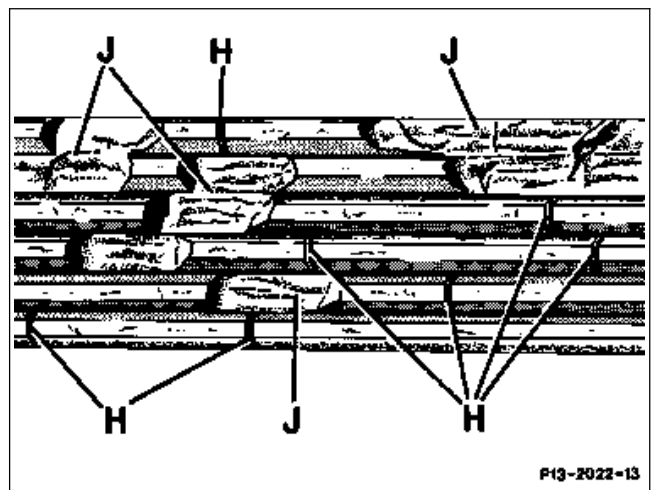
- Splitting across ribs (H) and/or sections of belt broken off (J).

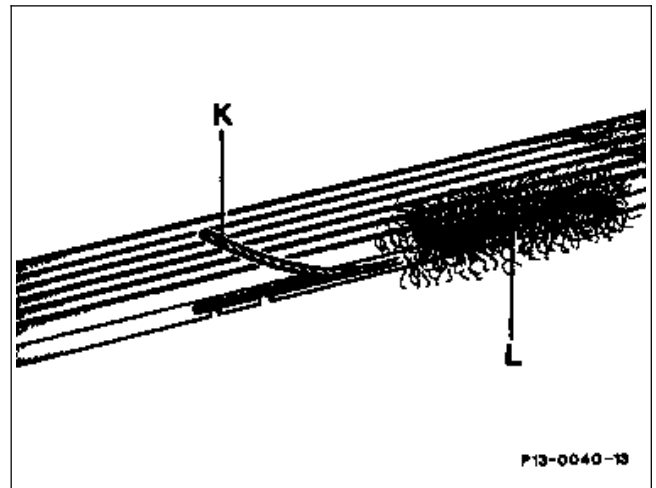
- Cord fractured at the side (K) or fraying (L) of outer cords.

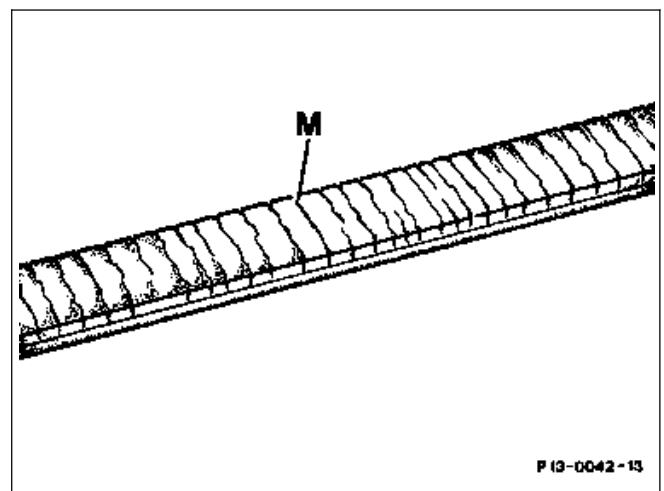
- Splitting across the back (M).
