S.G.N. **3310-06 REAR PROPELLER SHAFT**

## 3310-00 DISASSEMBLY AND REASSEMBLY PROPELLER SHAFT

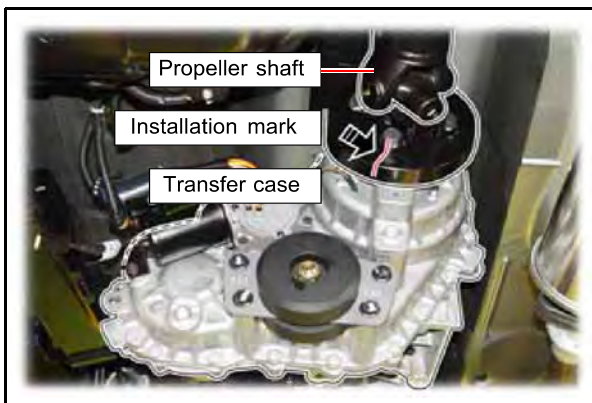
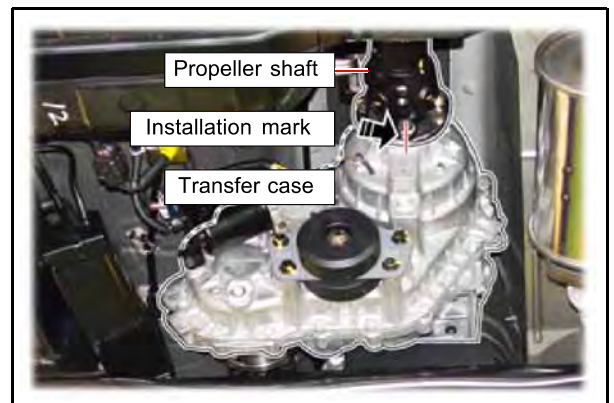
1. Remove the yoke mounting bolt and nut on the transfer case side of the rear propeller shaft.

- Put installation marks on the yoke of the rear propeller shaft and the flange of the transfer case.

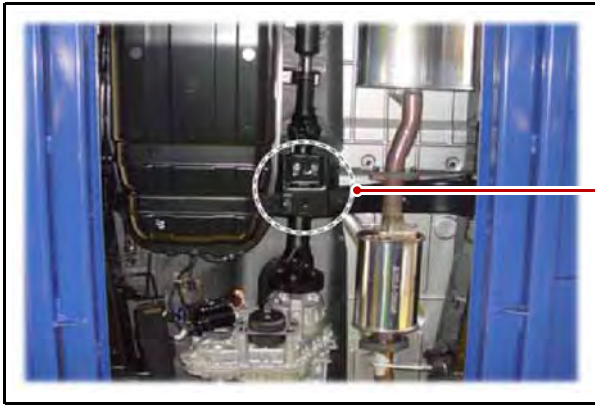
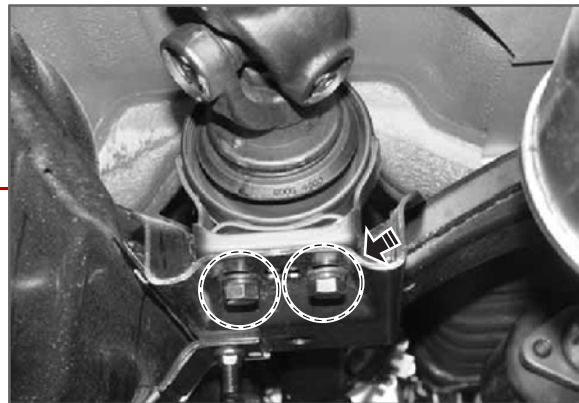
2. Remove the intermediate bearing(center) bolts.

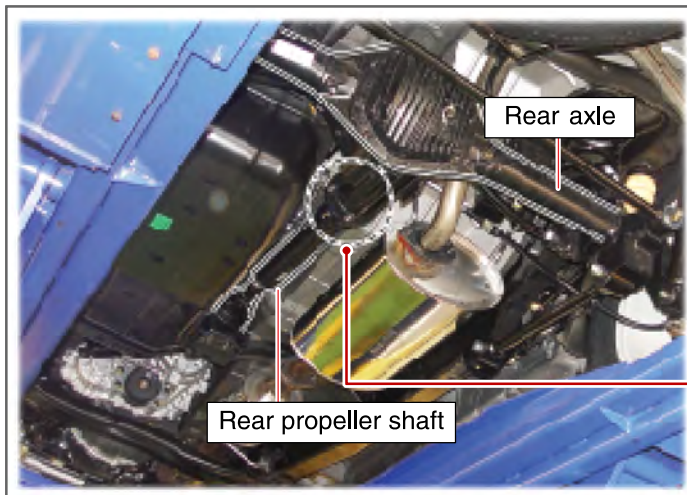
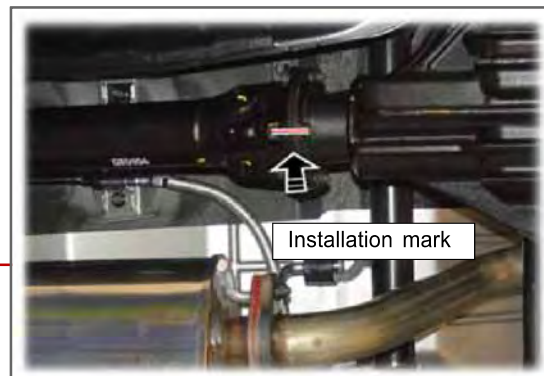
3. Remove the yoke and flange mounting bolts and nuts on the rear axle side of the rear propeller shaft. Then, remove the rear propeller shaft.

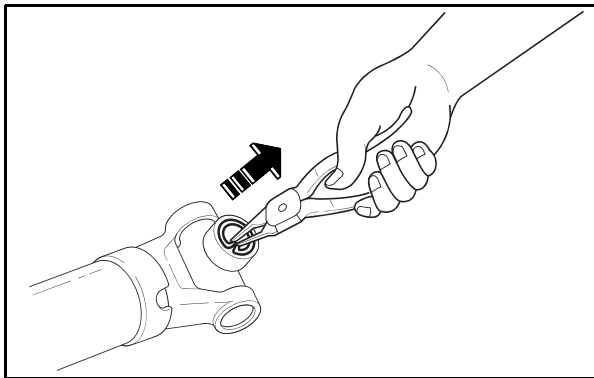
3. Remove the snap ring with snap ring pliers.

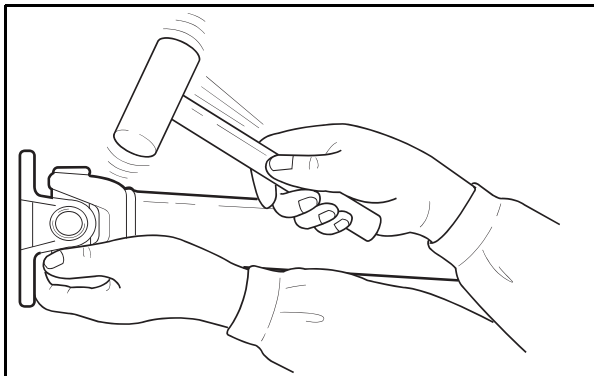
4. Tap the yoke shoulder on shaft with copper hammer to remove the roller bearing. Remove the other bearings with same manner.

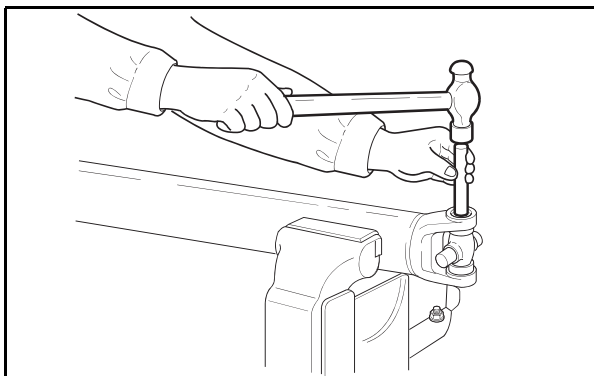
5. If it cannot be removed, hold the welding area with vise and remove the needle bearing by using a suitable drift and hammer.

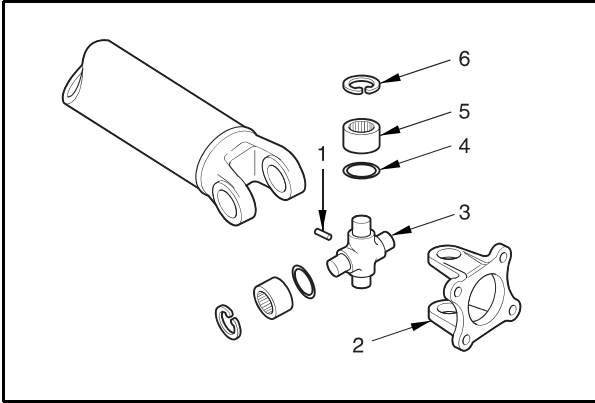
6. Disassemble the universal joint.

The universal joint compensates the angle changes due to vertical movement of the axle shaft.

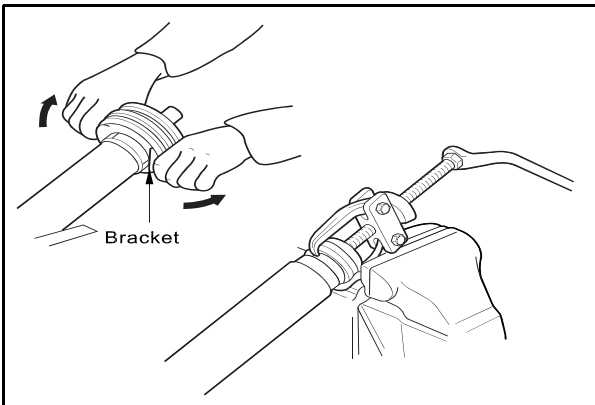
7. Remove the intermediate bearing bracket and remove the bearing with special tool.

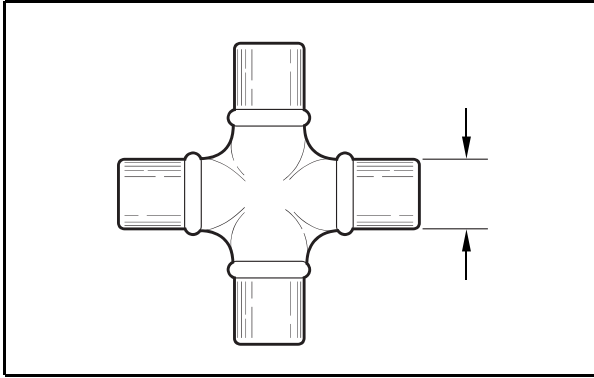
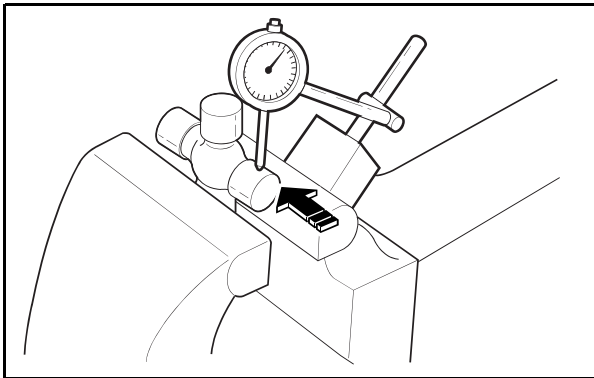
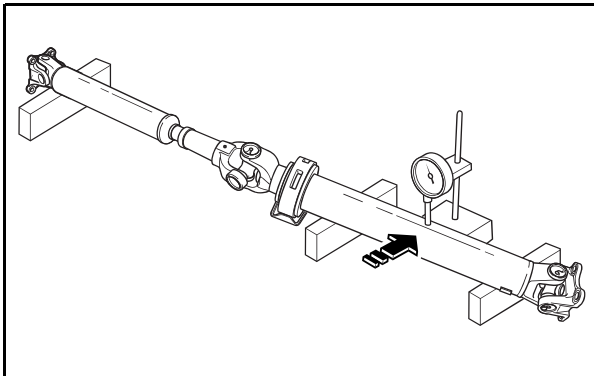
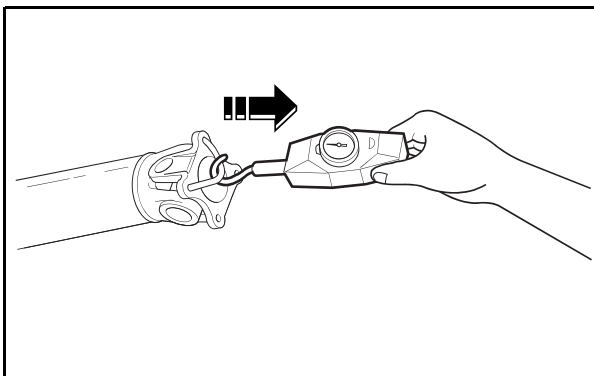
1. Visual Check Check the components for wear and crack and replace if needed.
2. Outer diameter of spider journal.

Specified value	17.893 mm
Limit	17.910 mm

3. Clearance between spider journal and bearing.

Specified value	0.03 ~ 0.098 mm
Limit	0.25 mm

4. Run-out of propeller shaft Set up the dial gauge on the center point of propeller shaft and measure the run-out. If the run-out is out of the specified range, correct it with press or replace it with new one.

Limit	0.4 mm
-------	--------

5. Starting torque of universal joint.

Specified value	3 ~ 8 kg.cm
-----------------	-------------
