2010 BMW M6

SUSPENSION Front Suspension - 650i, M6

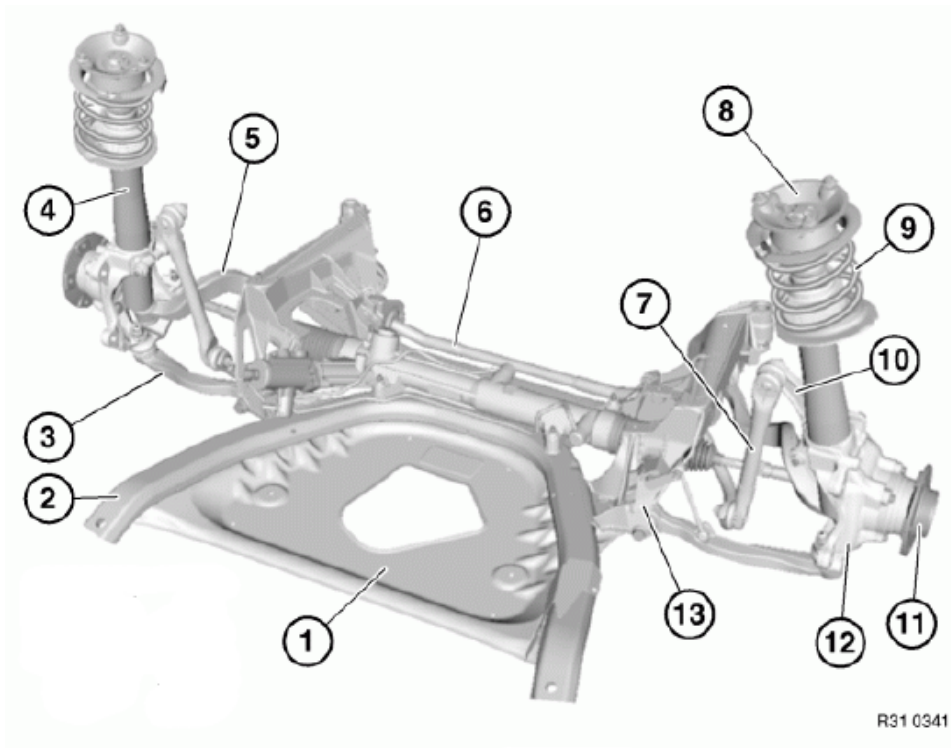
| 1 | Reinforcement plate | 9 | Coil spring |
| 2 | Front axle support | 10 | Stabilizer link holder |
| 3 | Control arm | 11 | Wheel bearing/drive flange |
| 4 | Spring strut shock absorber | 12 | Swivel bearing |
| 5 | Tension strut | 13 | Ride level sensor |
| 6 | Stabilizer/stabilizer suspension | | |
| 7 | Stabilizer link | | |
| 8 | Thrust bearing | | |

Fig. 3: Identifying Front Axle Components
Courtesy of BMW OF NORTH AMERICA, INC.

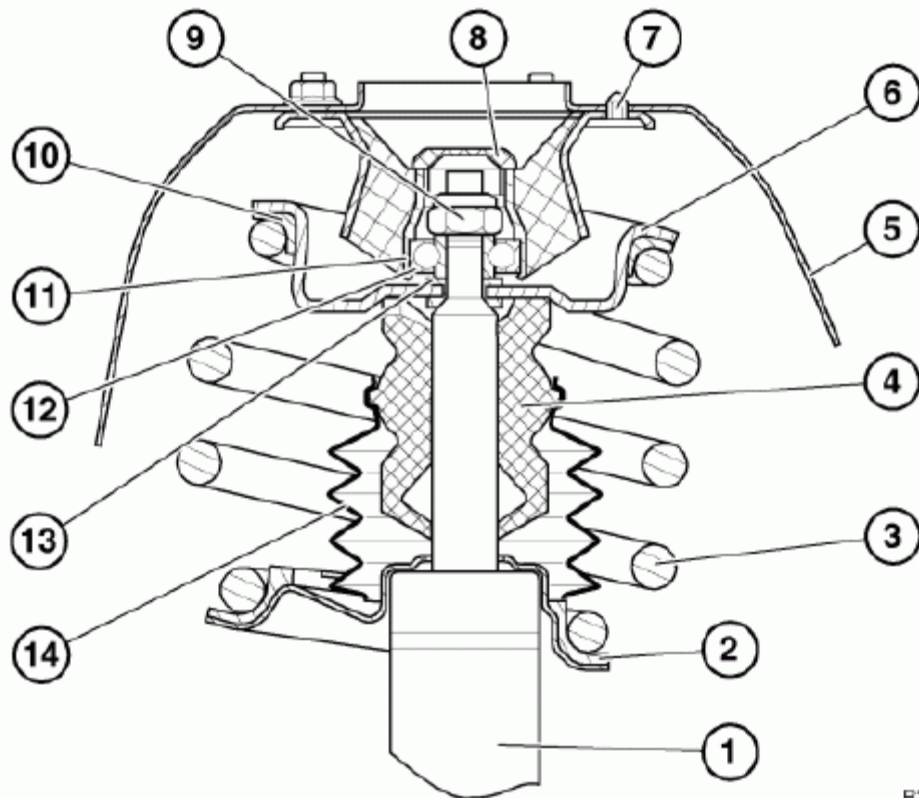
R31 0140

31 ... LAYOUT OF SPRING STRUT SHOCK ABSORBER

| 1 | Spring strut shock absorber | 10 | Upper spring pad |
| 2 | Lower spring pad | 11 | Thrust bearing |
| 3 | Coil spring | 12 | Dust sleeve |
| 4 | Auxiliary spring | 13 | Thrust washer/shim |
| 5 | Wheel arch | 14 | Rubber gaiter |
| 6 | Upper spring plate | | |
| 7 | Centering pin | | |
| 8 | Grease cap | | |
| 9 | Nut | | |

Fig. 4: Identifying Spring Strut Shock Absorber Components
 Courtesy of BMW OF NORTH AMERICA, INC.

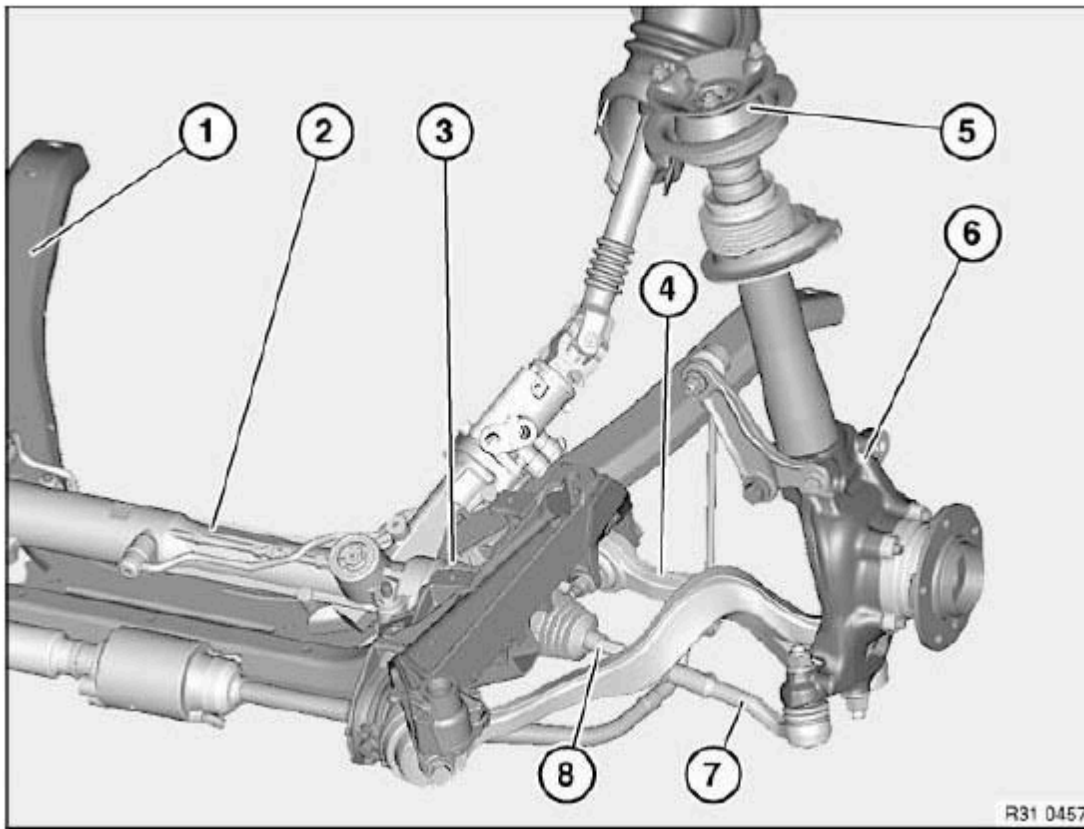
Fig. 5: Identifying Front Axle Components
Courtesy of BMW OF NORTH AMERICA, INC.

A wheel/chassis alignment check must be carried out after the following work:

- Release of following screw/bolt connections:
 - Steering gear to front axle carrier
 - Control arm to front axle carrier
 - Support bearing to body (if centering pin is missing)
 - Tie rod end to tie rod
- Replacement of following parts:
 1. Front axle carrier
 2. Steering gear
 3. Gaiter (if the tie rod end has to be screwed off)
 4. Control arm
 5. Support bearing (if centering pin is missing)
 6. Swivel bearing
 7. Tie rod end
 8. Tie rod

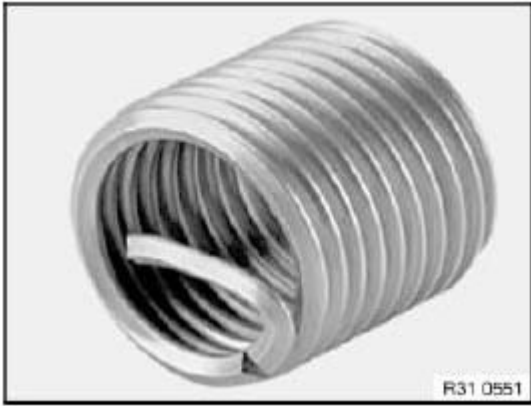
IMPORTANT: Install Helicoil thread inserts so that they are flush with the original thread.

NOTE: Damaged threads in engine carrier may be repaired with Helicoil thread inserts. Comply with the procedure described in the example.

Fig. 6: Identifying Damaged Threads
Courtesy of BMW OF NORTH AMERICA, INC.

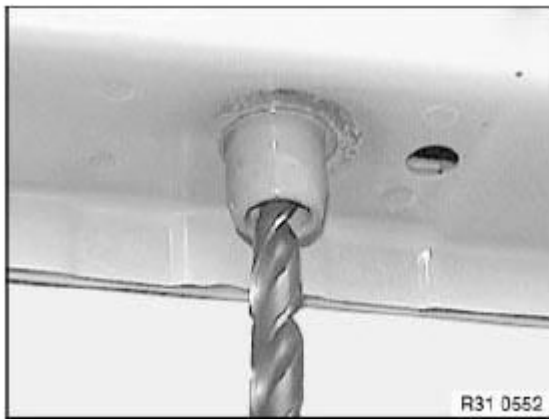
1. Create a clean core hole; if necessary, drill out screw remnants

Fig. 7: Drilling Out Screw Remnants
Courtesy of BMW OF NORTH AMERICA, INC.
