2014 Chevrolet Sonic LT

2014 ENGINE Engine Mechanical - 1.8L (LUW, LWE)

Exploded View Dual Mass Flywheel with Additional Mass

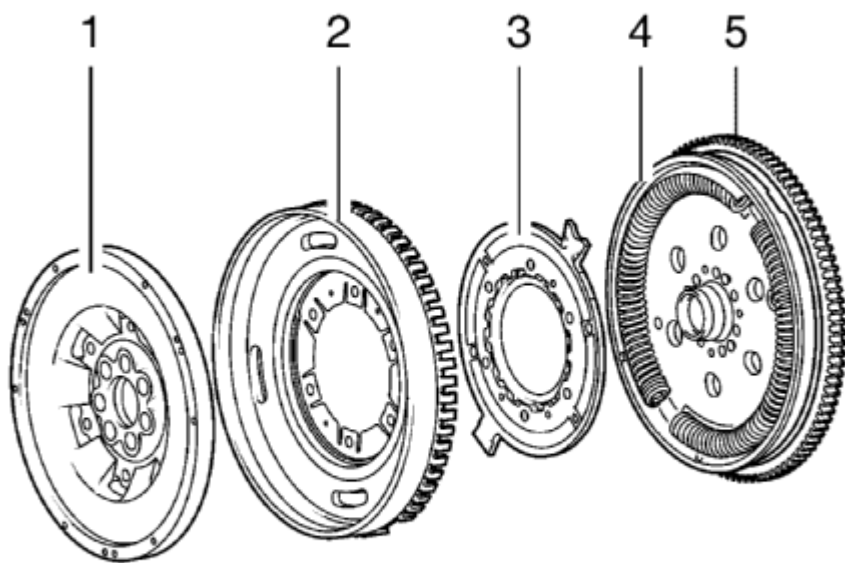
Fig. 8: Exploded View Dual Mass Flywheel with Additional Mass
Courtesy of GENERAL MOTORS COMPANY

Callout	Component Name
1	Secondary Flywheel Mass
2	Additional Mass, Coupled with Cover and Pulse-Generator Ring
3	Flange
4	Primary Flywheel Mass with Bowed Springs and Plain Bearing/Bearing Bolt
5	Toothed Ring

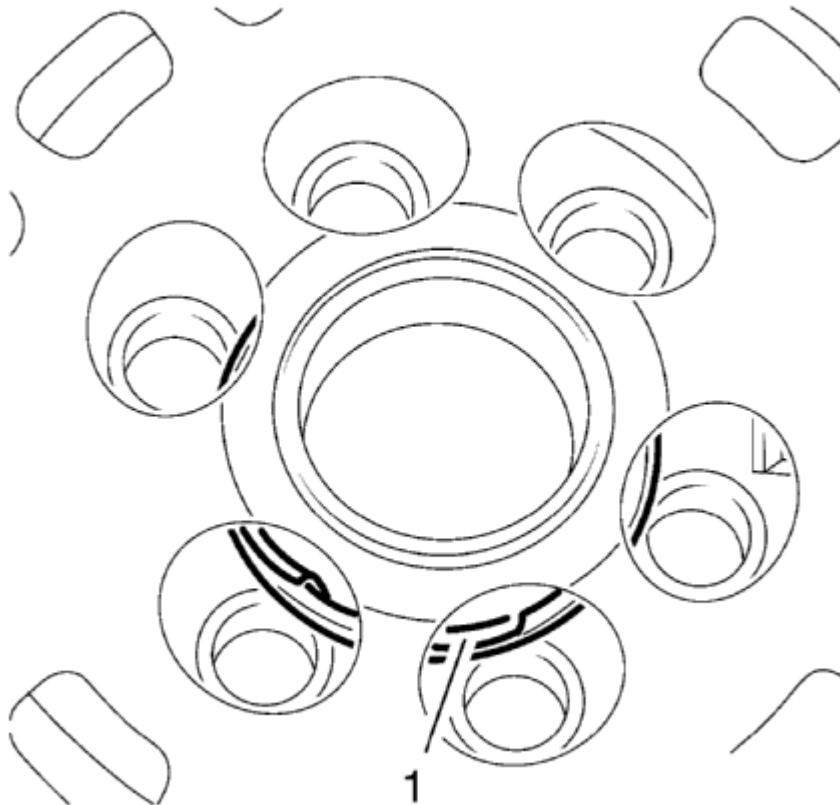
Fig. 9: Plain Bearing

NOTE: In case of mechanical damages at plain bearing the dual mass flywheel has to be replaced.

1. Inspect plain bearing (1) for damages.

Dependent of the manufacturer damages can be detected through ventilation openings of secondary flywheel. Parts of the bearing (1) are detached or lie loose around the bearing bolt.

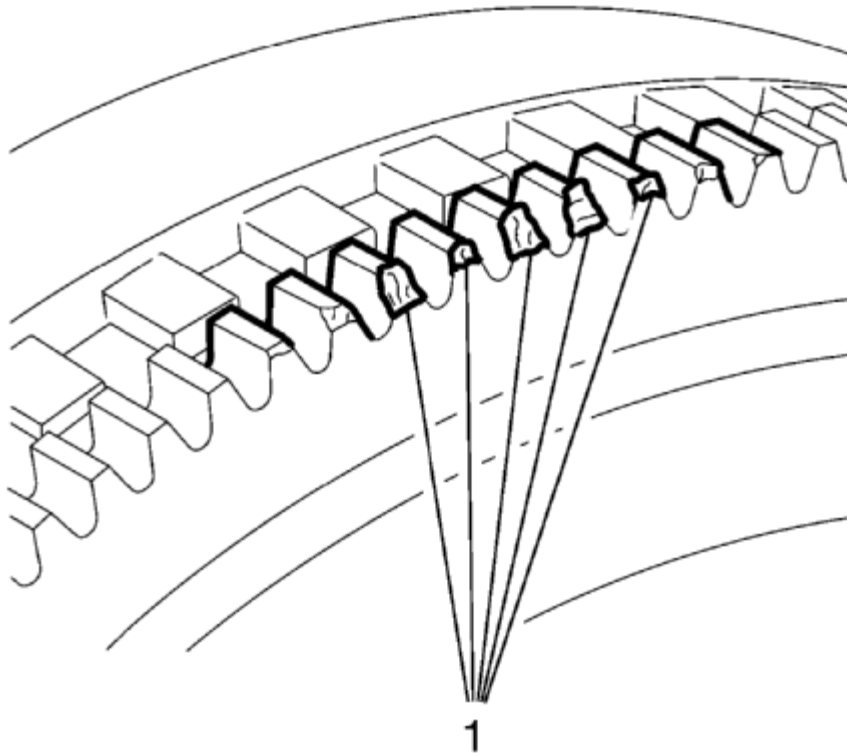
Fig. 10: Toothed Ring

NOTE: Light abrasion on frontal areas of teeth is allowed. If problems occur during starting the engine the dual mass flywheel has to be replaced.

2. Inspect toothed ring (1) for damages.

The toothed ring is needed to start the engine. Through a lot of starting procedures and/or an incorrect engaging starter signs of abrasion can occur on teeth of the toothed ring. The profile of damages can reach from only low signs of abrasion up to heavy material removal. The installation of a pulse-generator ring depends on the manufacturer.

The image shows signs of abrasion and mechanical damages at toothed ring (1), they occur through abrasion due to a lot of starting procedures. In this case the dual mass flywheel has to be replaced.

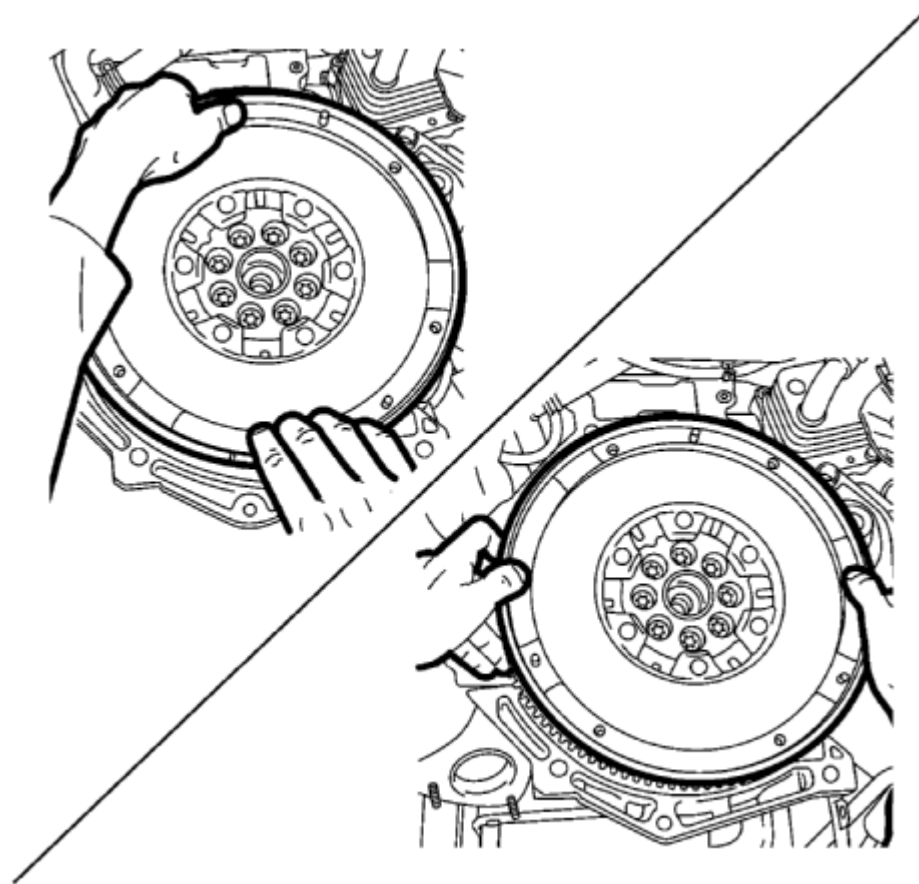
Fig. 11: Inspecting Tilt Clearance

NOTE: The check must be carried out only by hand without any tools.

3. Inspect tilt clearance.

At dual mass flywheel the additional-mass ring looms over the gap between primary and secondary flywheel. It is not possible to carry out just a visual check.

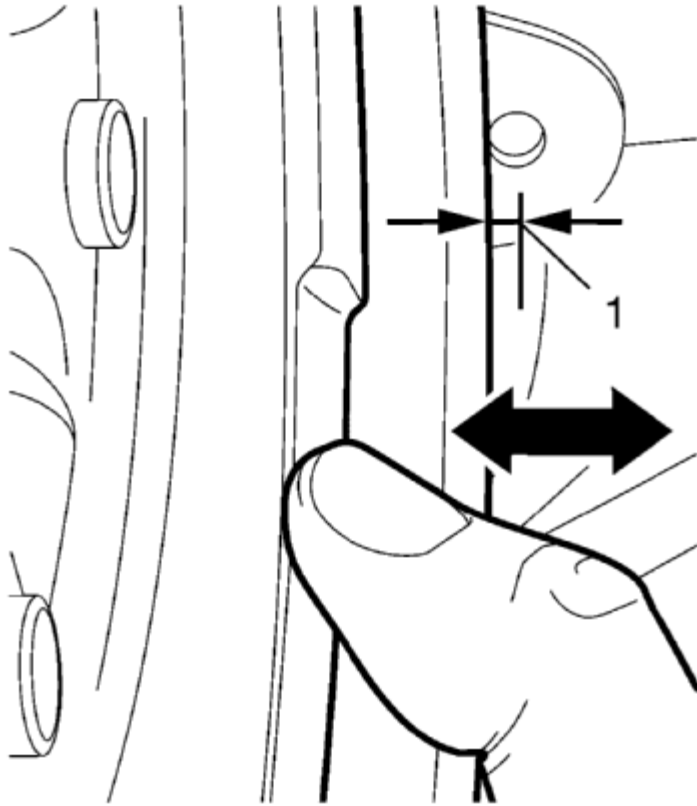
Fig. 12: Tilt Clearance Height

NOTE: An absolute clear measurement is not possible with this check due to the different applied forces of the several workshop employees during the check.

4. Embrace dual mass flywheel and apply thumbs onto the outer radius of secondary flywheel.
5. Apply pressure onto the secondary flywheel alternating on upper, lower, left and right side

During the tilt clearance check a functional metal rattling noise may occur.

If tilt clearance is higher than 3 mm (MUST be measured, DO NOT make an estimation) (1) the dual mass flywheel has to be replaced.

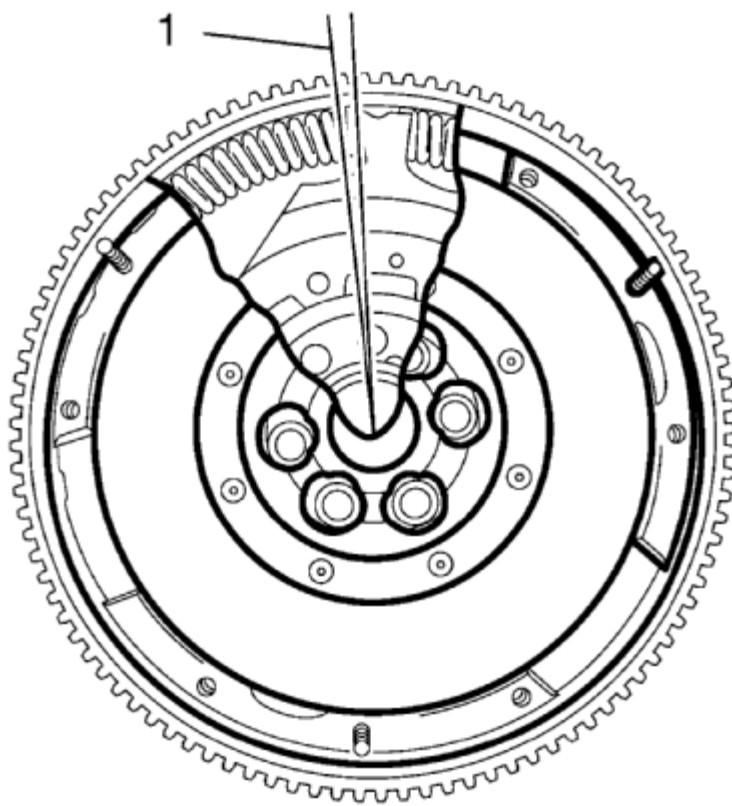
Fig. 13: Tilt Clearance Angle
