TRACK MAINTENANCE (CONT'D)

Track Damage Identification (Cont'd)

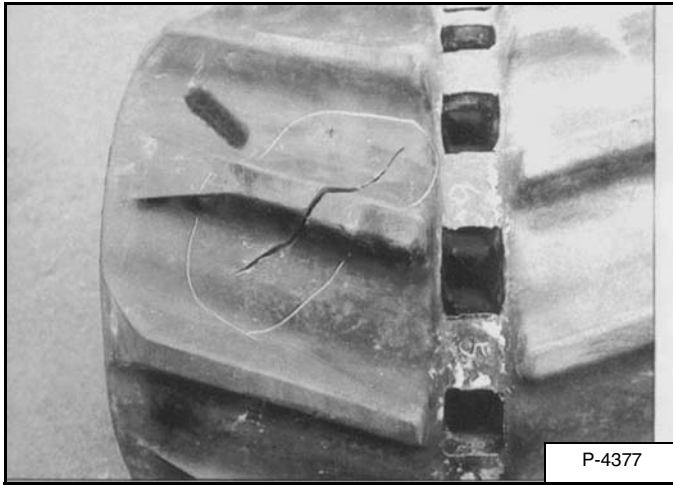
Figure 30-30-12

Cuts On The Lug Side Rubber

Cuts on the lug side rubber often occurs as one of the most typical failure modes [Figure 30-30-12]

When a cut on the lug side rubber reaches the embedded steel cords, it should be immediately repaired with cold vulcanization rubber.

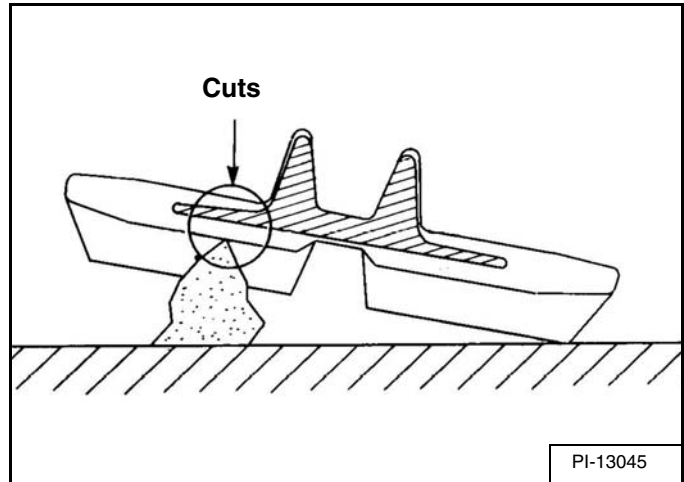
Figure 30-30-13

When rubber tracks drive over projections or sharp stones in the fields, the concentrated forces applied cause cuts on the lug side rubber surface. In case of making turns on projections, the lug side rubber surface will have an even higher chance to be cut. If the cuts run through the embedded steel cords, it might result in the steel cords' breakage due to their corrosion. It is highly recommended to repair the cuts with cold vulcanization rubber as soon as they are observed [Figure 30-30-13].

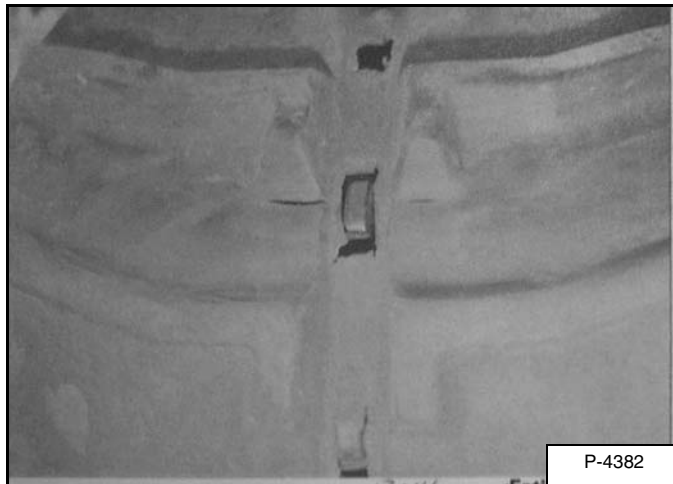
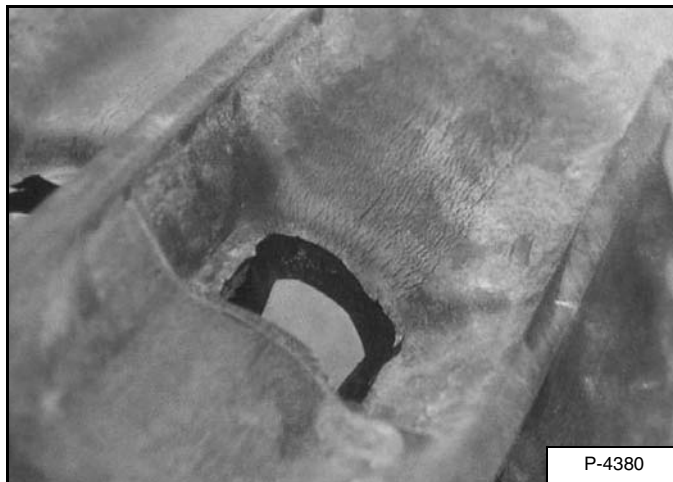
Cracks On The Lug Side Rubber Due To Fatigue

Small cracks around the root of the lug as a result from operation fatigue [Figure 30-30-14] and [Figure 30-30-15].

When the cracks reach so deep that they expose the steel cords, track replacement is required.

Because of wound stress applied to rubber tracks around the undercarriage parts during operation, the fatigue especially causes cracks on the lug side rubber surface. Once the cracks occur, they gradually deteriorate with even small external cracks. When operating near seashores or under cold temperatures, rubber tracks are more likely to suffer from ozone cracks.

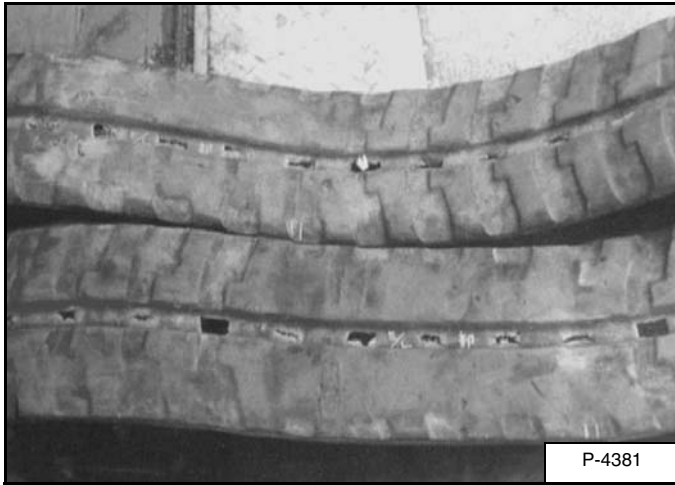
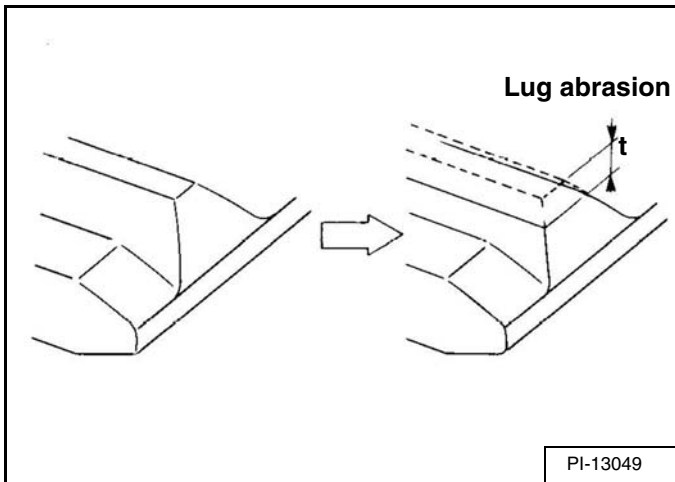
Lug Abrasion

As its service time proceeds, the lug side inevitably undergoes abrasion [Figure 30-30-16] and [Figure 30-30-17].

Lug abrasion is inevitable. Even if lug abrasion is proceeding, the rubber track can be used. As the traction performance deteriorates accordingly, it is highly recommended to replace the abraded tracks with new ones when the lug height becomes less than 5 mm (0.197 in).

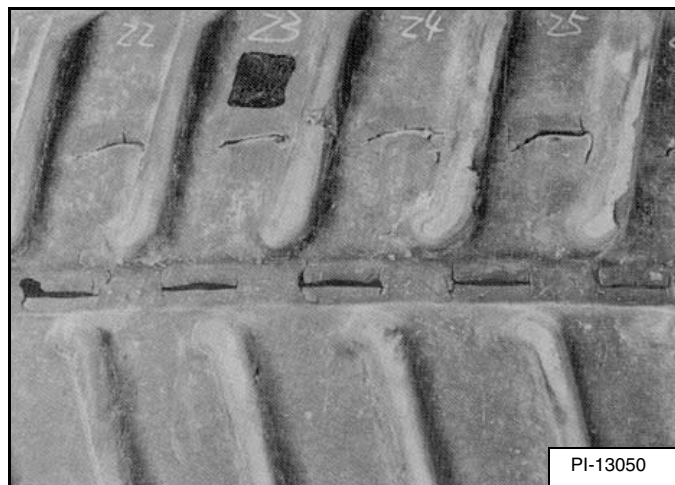
Figure 30-30-18

Cracks And Cuts On The Lug Side Rubber

Sometimes cracks and cuts on the lug side rubber at the edges of the embedded metals can be observed [Figure 30-30-18].

No replacement is required unless the cuts on the lug side rubber are discovered all around the edges of the embedded metals, as this will result in a complete cut off.

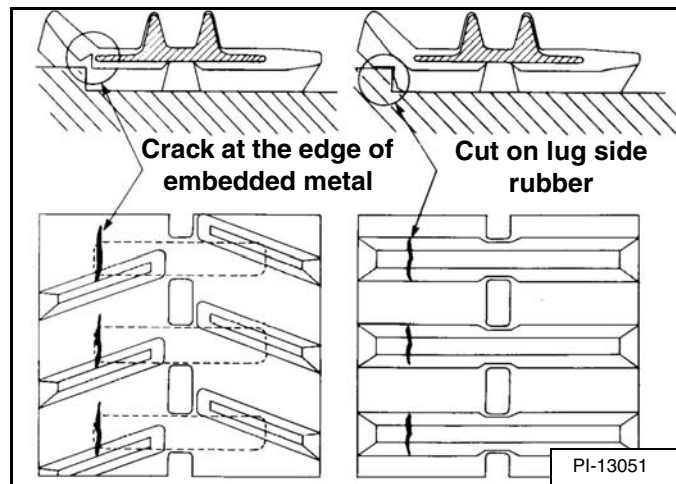
Figure 30-30-19

When rubber tracks drive over sharp projections, intensive stress is applied to the lug side rubber surface, especially at the edges of embedded metals, causing cracks and cuts in the area around the embedded metals [Figure 30-30-19].
