## GENERAL

### Bank Angle Sensor

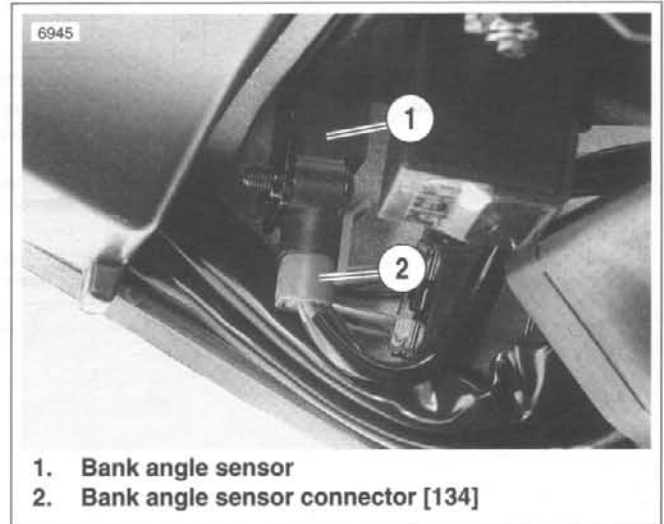
Figure 4-63. Bank Angle Sensor

1. Bank angle sensor  
2. Bank angle sensor connector [134]

See Figure 4-63. A Code 44 occurs when the bank angle sensor voltage is outside the normal operating range of 0.6-1.1 volts. This may be caused by:

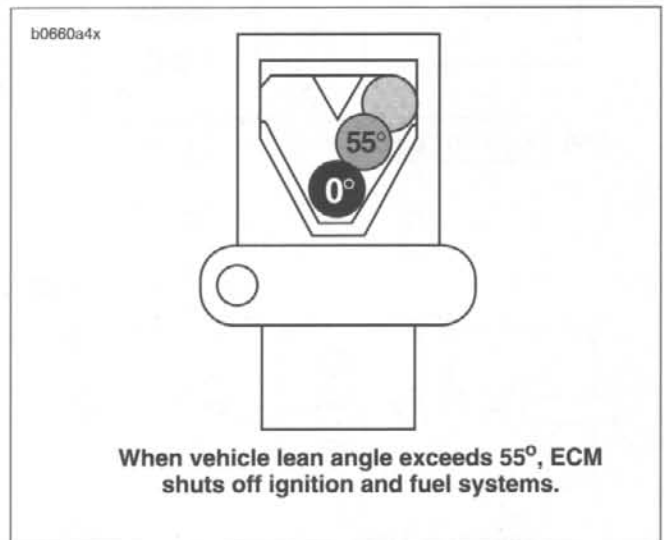
Figure 4-64. Bank Angle Sensor Operation

When vehicle lean angle exceeds 55°, ECM shuts off ignition and fuel systems.

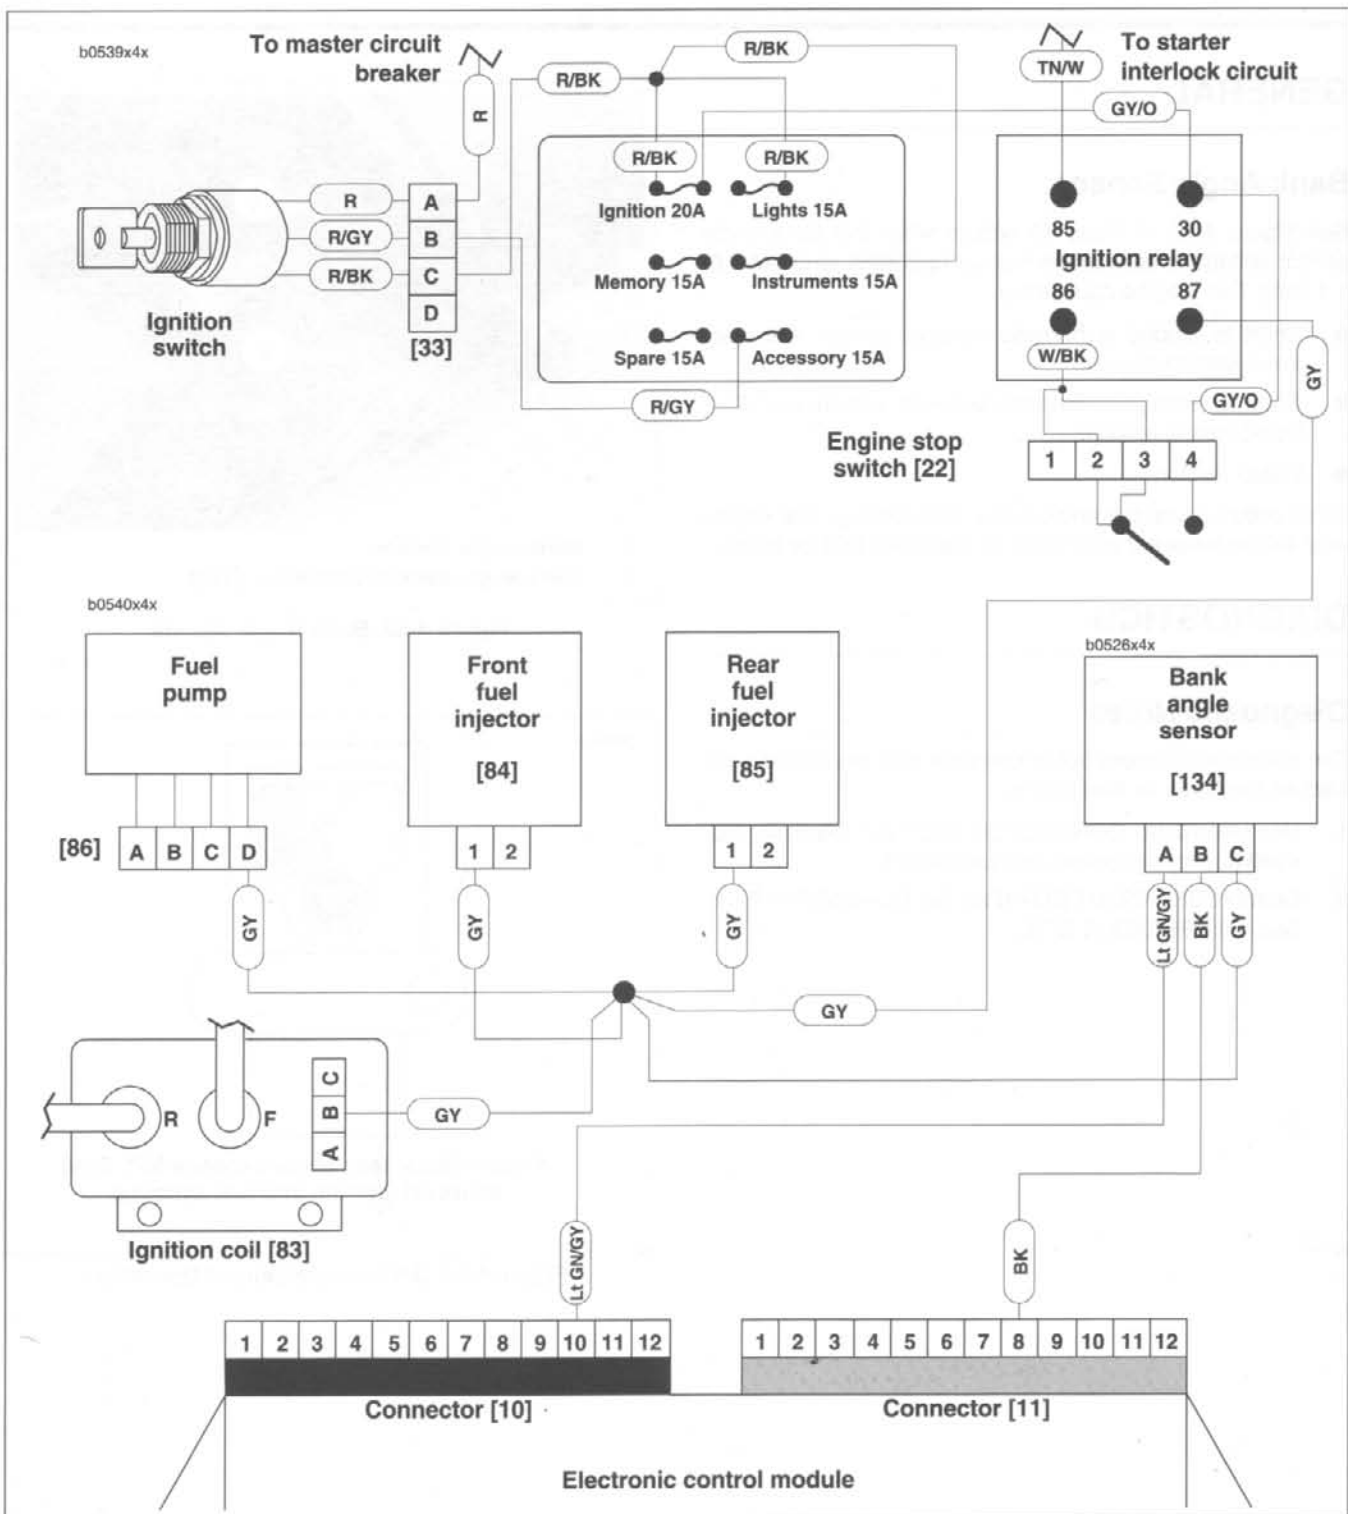
Figure 4-65. Bank Angle Sensor Circuit

NO.	DESCRIPTION	TYPE	LOCATION
[10]	ECM (black)	12-place Deutsch	under seat
[134]	Bank angle sensor	3-place Packard	under tail section, left side

Table 4-25. Wire Harness Connectors in Figure 4-65.

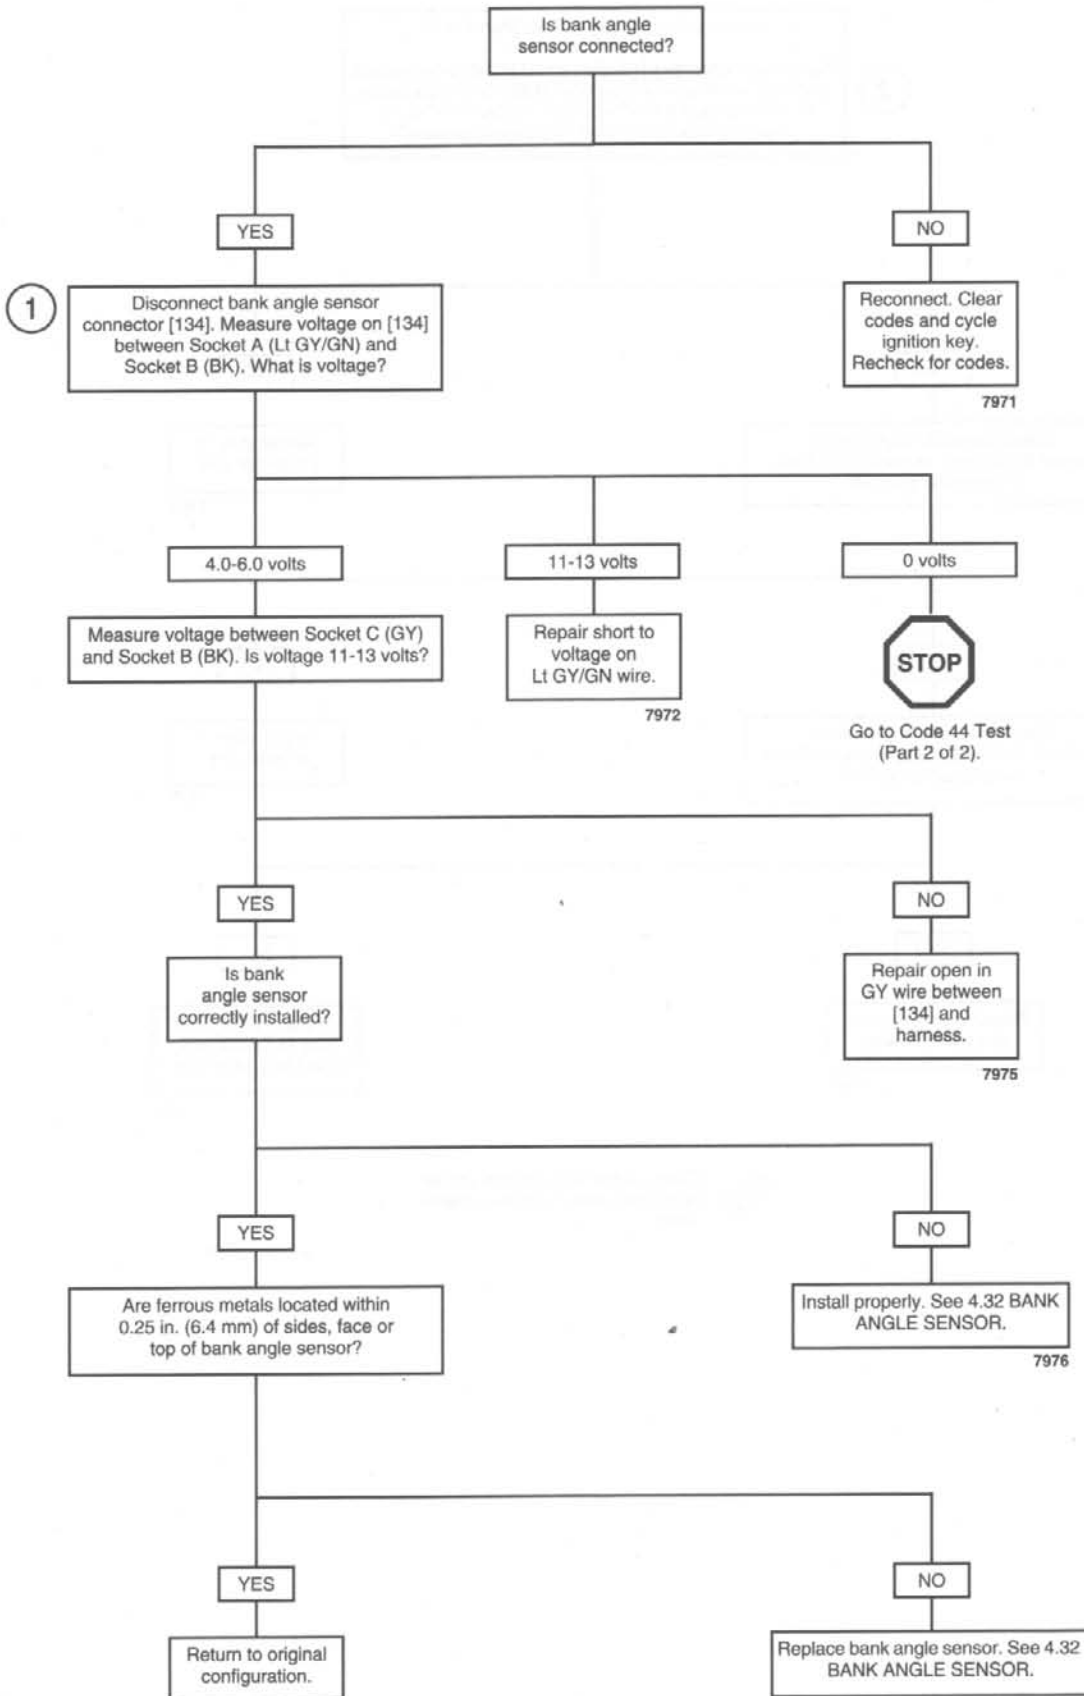
# Code 44 Test (Part 1 of 2)

The reference numbers below correlate with the circled numbers on the Code 44 flow charts.

1. Use HARNESS CONNECTOR TEST KIT (Part No. HD-41404), gray pin probes and patch cord.
2. Connect BREAKOUT BOX (Part No. HD-42682) to ECM. See 4.6 BREAKOUT BOX.

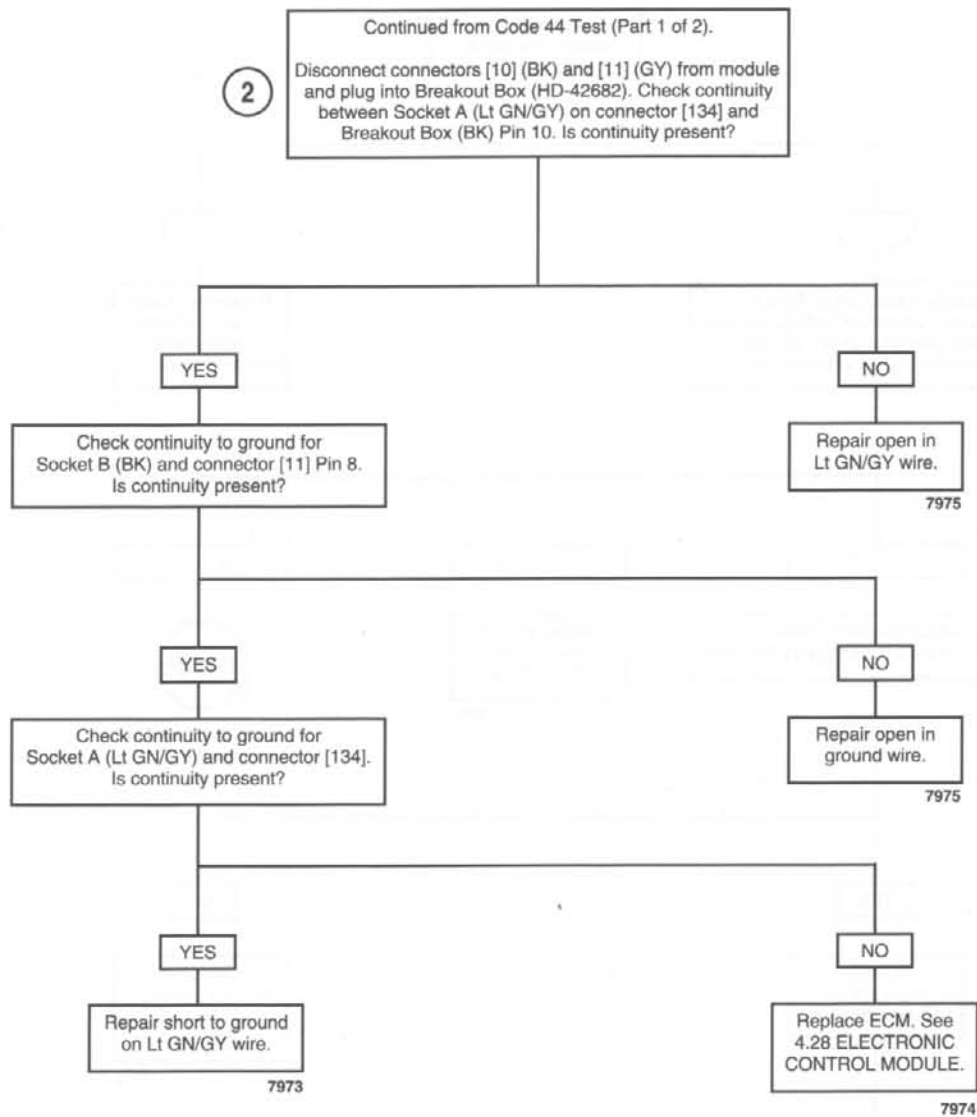
## Code 44 Test (Part 2 of 2)

Clear codes and confirm proper operation with no check engine lamp.
