**STEP 12. Check rear passenger's door lock actuator (LH) connector H-13 for loose, corroded or damaged terminals, or terminals pushed back in the connector.**

**STEP 13. Check the rear passenger's door lock actuator (LH).**

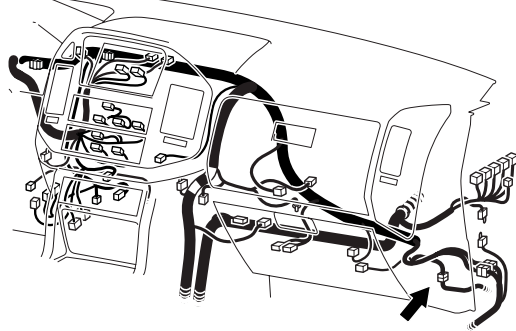
**CONNECTOR: D-15**

*NOTE: Also check junction block connector D-217 and intermediate connector D-15 for loose, corroded, or damaged terminals, or terminals pushed back in the connector. If junction block connector D-217 or intermediate connector D-15 is damaged, repair or replace the damaged component(s) as described in GROUP 00E, Harness Connector Inspection [P.00E-2](#).*

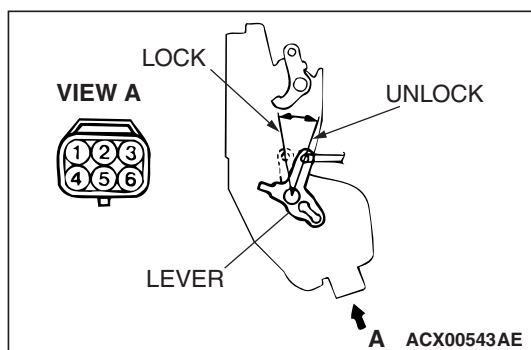
**CONNECTOR: H-13**

**Q: Is rear passenger's door lock actuator (LH) connector H-13 in good condition?**

**NO :** Repair or check the connector. Refer to GROUP 00E, Harness Connector Inspection [P.00E-2](#). After repairs have been made, verify that all the doors can now be locked and unlocked normally.

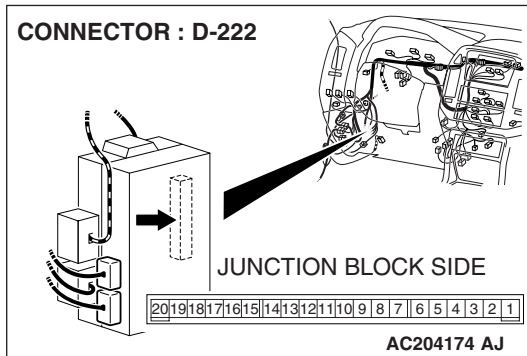
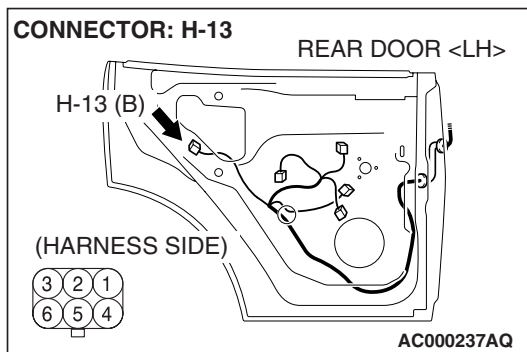
**STEP 15.** Check the harness wiring from ETACS-ECU connector D-222 (terminal 4) to rear passenger's door lock actuator (LH) connector H-13 (terminal 4).

**Q:** Is the harness wiring from ETACS-ECU connectors D-222 (terminal 4) to rear passenger's door lock actuator (LH) connector H-13 (terminal 4) in good condition?

**NO :** The harness wiring may be damaged or the connectors may have loose, corroded or damaged terminals, or terminals pushed back in the connector. Repair the harness wiring as necessary. After repairs have been made, verify that all the doors can now be locked and unlocked normally.

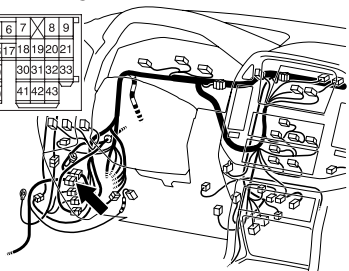
**CONNECTOR : D-125**

**NOTE:** Also check junction block connector D-217 and intermediate connector D-125 and F-12 for loose, corroded, or damaged terminals, or terminals pushed back in the connector. If junction block connector D-217, intermediate connector D-125 or F-12 is damaged, repair or replace the damaged component(s) as described in GROUP 00E, Harness Connector Inspection [P.00E-2](#).

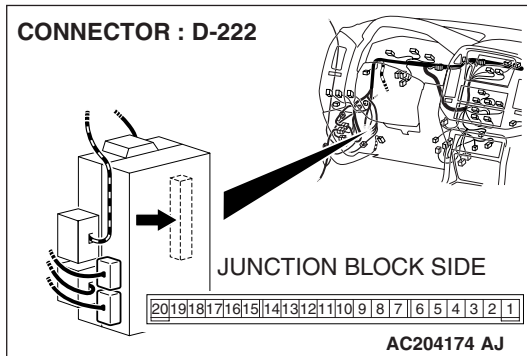
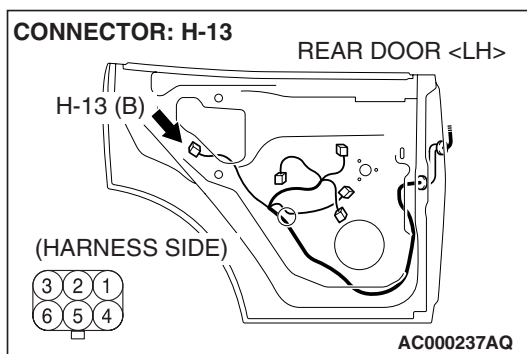
**STEP 16.** Check the harness wiring from ETACS-ECU connector D-222 (terminal 17) to rear passenger's door lock actuator (LH) connector H-13 (terminal 6).
