Revision: April 2013 EXT-2 2014 Versa Sedan

SQUEAK AND RATTLE TROUBLE DIAGNOSES

FRONT BUMPER

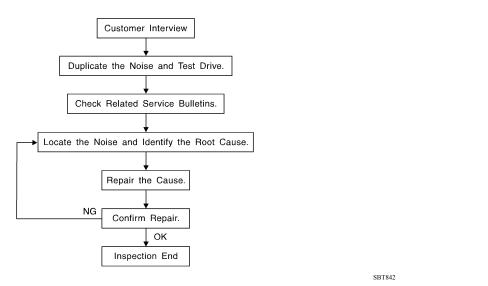
Work Flow

CUSTOMER INTERVIEW

Interview the customer if possible, to determine the conditions that exist when the noise occurs. Use the Diagnostic Worksheet during the interview to document the facts and conditions when the noise occurs and any customer's comments; refer to EXT-13, "Diagnostic Worksheet". This information is necessary to duplicate the conditions that exist when the noise occurs.

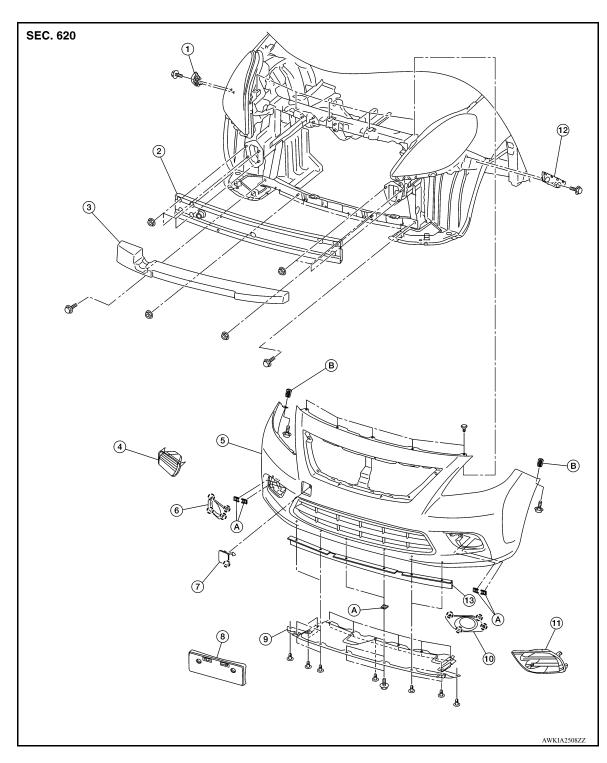
Exploded View

- 1. Front bumper side bracket (RH)
- 4. Front bumper fascia finisher (RH) (If equipped)
- 7. Tow cover

- . Front bumper reinforcement
- Front bumper fascia

- 3. License plate bracket
- 3. Front bumper energy absorber
- 6. Fog lamp finisher (RH) (if equipped)
- 9. Under cover

- 10. Fog lamp finisher (LH) (if equipped)
- 11. Front bumper fascia finisher (LH) 12. Front bumper side bracket (LH) (if equipped)

13. Front spoiler

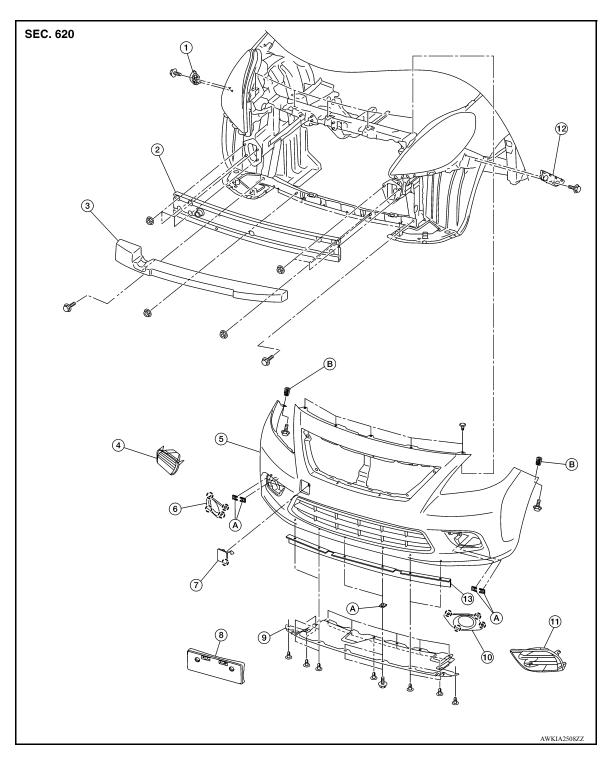
Exploded View

- 1. Front bumper side bracket (RH)
- 4. Front bumper fascia finisher (RH) 5. (If equipped)
- 7. Tow cover
- 10. Fog lamp finisher (LH) (if equipped)
- . Front bumper reinforcement
- 5. Front bumper fascia
- 8. License plate bracket
- Front bumper fascia finisher (LH) (if equipped)
- 3. Front bumper energy absorber
- 6. Fog lamp finisher (RH) (if equipped)
- 9. Under cover
- Front bumper fascia finisher (LH) 12. Front bumper side bracket (LH)
